SAFETY MEMO

May 31st, 2021 – Natural Gas Pipe Collision

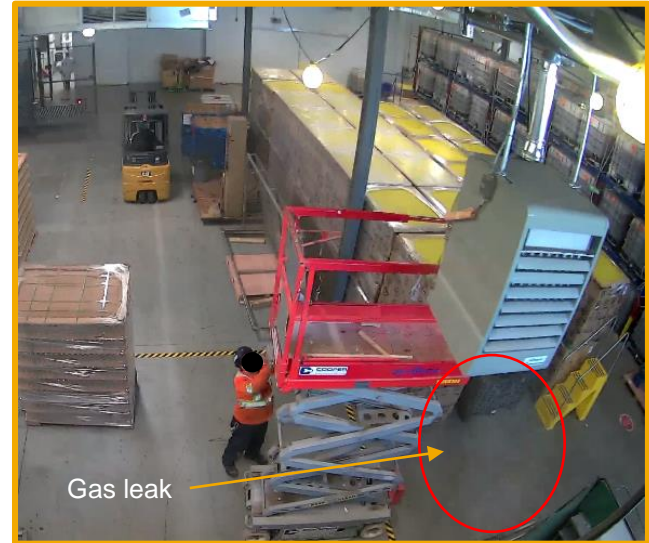
During the inspection, the mechanic elevated the lift and attempted to move it forward. As he moved the scissor lift, the raised platform violently struck a gas feed pipe connected to a gas heater, which caused a rupture of the pipe and the pressurized gas escaped into the warehouse area.

Had the gas leak not been identified by the facility staff, the warehouse could have filled with gas, causing an explosion. The resulting consequences of the explosion could have been extremely severe.

- A job hazard analysis could have identified the gas piping in the work area. The best way to control risk is to simply eliminate the risk, thus a different work area should have been chosen for the inspection.
- When an incident occurs, always notify a supervisor immediately.
- When work is done by an independent subcontractor, never assume that a job hazard analysis was completed.
- A job hazard analysis should be completed by all sub-contractors prior to starting any work on site and this must be communicated to all contractors working on site as a part of their safety orientation.
