SAFETY MEMO

February 28th, 2022 – Interstitial Space

Incident Description

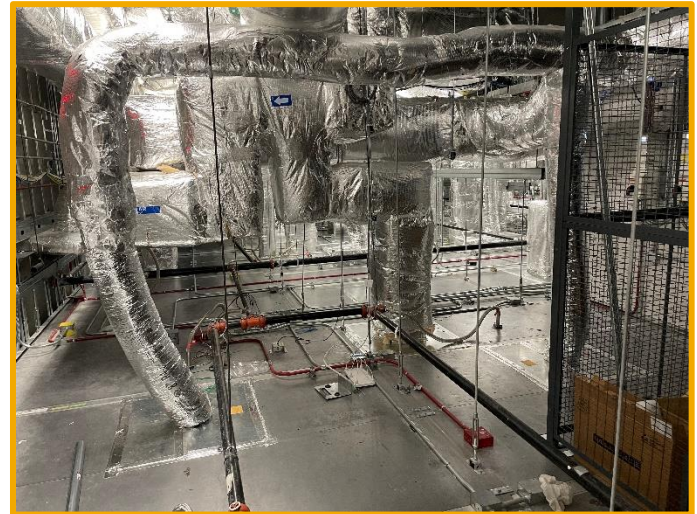
A worker went to the walking cellar space above a production room where the HVAC units are installed. He needed to set up and prepared for the future installation of filters for the HVAC units. The goal was not to install the filters but to prepare the area and equipment for the installation to happen in the next week to save time during the shutdown (inventory of filters needed, staging the area, put filters next to units). The worker ducked under a support structure and misjudged the space above him when standing up. He hit his head on a threaded rod (Unirod) used as a support to hold a unit trust. At the time of the incident, the worker was not wearing any head protection.

- Unirod protruding well below support structure
- Unibolt did not have a protective cap on it
- No signage at entrance indicating low ceiling with protruding objects

A cummulation of several small events and circumstances, the worker received a laceration to the top of their head that required staples to close the wound.

- Everyone is responsible for its own safety, and you can't rely on a client to identify risk and required mitigation measures.
- It is important to remind ourselves to take time and put safety first.
- No one will ever call you out because you take the time to do things safely
