SAFETY MEMO

September 19, 2022 – Purified Water Spill

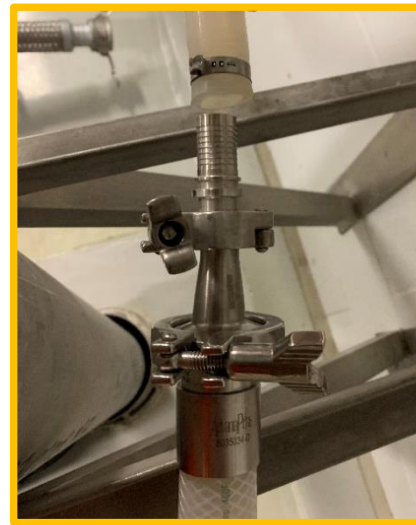
Image 1: barbed fitting with clamp

When testing the opening of this valve, the purified water request was sent to the PW system. Once the request was sent, the valve opened, and water began to flow down the drain. Moments after the valve opened, the pressure in the system caused the failure of the connection between the two hoses. The fitting was projected, and water then poured into the hall, which at the time was an active construction site.

- The type of Tri-Clamp connection required between the two flexible piping's was not specified to the technician responsible for installing the pipes
- The connection between the two hoses was not checked before performing the test

- The connection between the hoses was a barbed fitting with a clamp, not suitable for the operating pressures of the system (see photo)
- No manual valve at valve outlet to control flow

- Use adapted tri-clamp type connections to connect flexible hoses
- Secure the hoses to prevent whipping effect in case of rupture
- Install a manual valve directly at the outlet of the automatic valve so that the flow can be controlled or stopped completely if necessary
- Specify the type of connection required if the installation is carried out by someone else
- Always check each connection before starting a test
- When a valve is tested for the first time, be sure to use a medium to low temperature
